FRONT CLAMPS FOR SPRITE MK2 / MIDGET MK1 FACTORY HARDTOPS

(see MASCOT Nov 2019 p36)

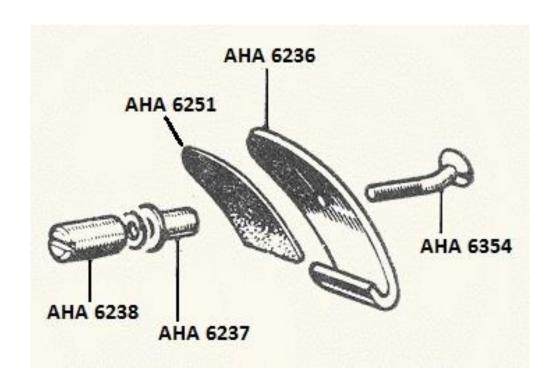
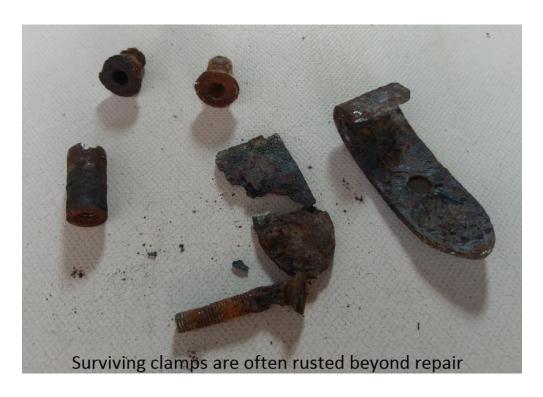
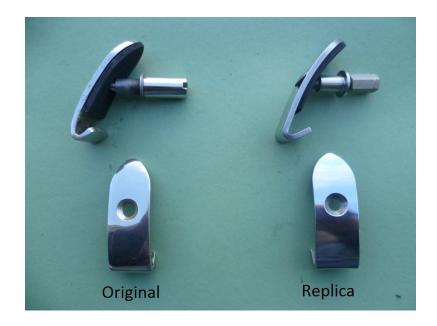
AHA 6236 This is the part that has proved the most difficult & time consuming to make. A local Engineering Firm managed (finally) to make them on their bending machine, starting from laser-cut pieces of satin finish stainless steel. The result was worth the 10-month wait delayed by Covid19: they are an extremely good match to the original parts.

AHA 6354 These started life as standard M6 stainless steel coach bolts. The head of each was first machined on a lathe to give the correct diameter and the correct countersunk chamfer. Glossing over many failed attempts to bend them, they were finally bent successfully by (a) gripping them firmly in a vice (b) heating the head of the bolt until it glowed bright red hot and then (c) gripping the head with a pair of pliers and bending it with an action rather like a dentist pulling a tooth. Inevitably, there will be a few witness marks on the heads of these bolts, a consequence of how they were made. The bend angle (very critical) was achieved using an original as a template followed by trial & error fitting on one of my hardtops.

AHA 6238 The original nut is cylindrical with a slot in the end to receive a one-penny piece or similar. I have substituted a standard 'long-hex' M6 nut which serves just as well if a 10mm socket is used to tighten it rather than a one penny piece. These nuts should not be over-tightened.

AHA 6327 These 'top hat' spacers should still be firmly in your hardtop but they can either fall out or rust out (and so become lost). If they are still in your hardtop, you will not need these extra bits. The new washers are exact replicas of the originals (same measurements), but made from stainless steel.

AHA 6251 Each clamp comes with a rubber pad to sit between clamp and hardtop. I've never seen an original 'sealing pad' but it must have been something like this.

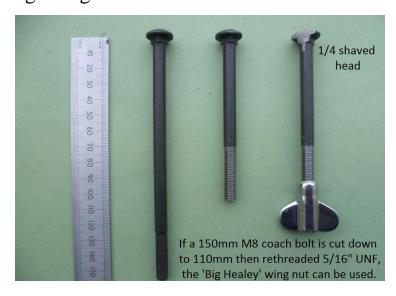
- 1. The original clamps were always something of a b****r to fit the bolts always seemed to be a little too short and the fit just a little too tight. It was often very hard to make the head of the bolt fit snugly into the countersunk hole in the bracket. The replicas are a little easier to fit because the bolts are a little longer and their diameter is a little less than an original UNF bolt. Nevertheless, the fit may not be perfect but then the original fit of most bits on these cars was never perfect!
- 2. When fitting the hardtop, I recommend first loosening the four set screws which secure the two rear brackets to the hardtop. Then secure the hardtop to the windscreen with the two new clamps. Then install the two coach bolts at the rear and tighten the two wing nuts. Then, to finish the job, tighten the four set screws which were loosened at the beginning.
